APPLEMORE HEALTH AND LEISURE CENTRE, URGENT ROOF REPAIRS

Re: Applemore Recreation Centre, Claypits Lane, Dibden – Main Flat Roof Area

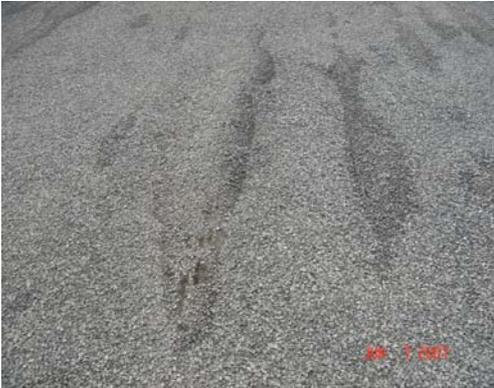
Extensive Raised/Detached Areas Evident

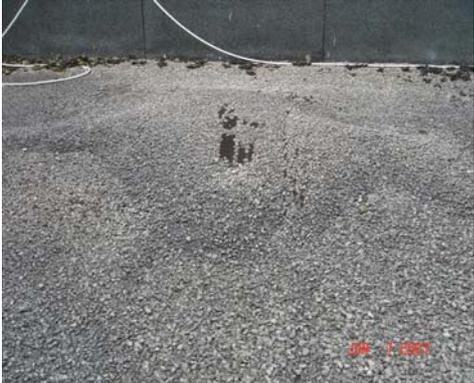
Further Extensive Raised Areas Present

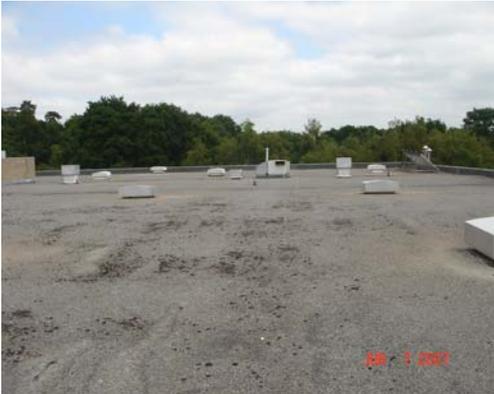
The existing felted covering is blistered, bubbled, and cracked to a varying degree throughout with extensive degeneration evident. Specific sections of the roof, mainly to above the Sports Hall facilities & Office Area appear to be further excessively bubbled and degenerated, indicating a possible variance in specification, however this has not been confirmed/determined.

General Overview Highlighting Extensive Defects

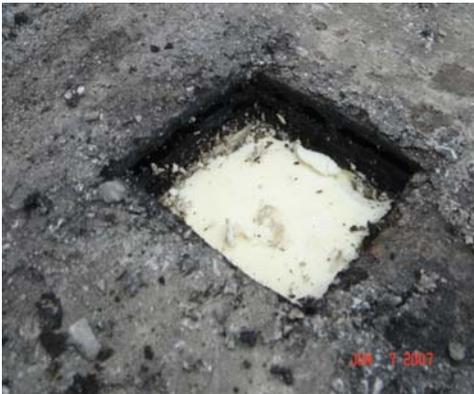
Confirming Roof Build Up

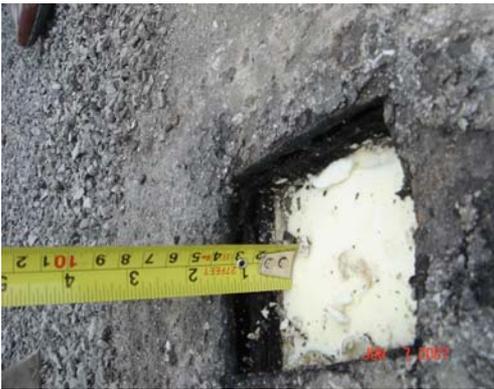
Confirming Depth of Membrane Build Up

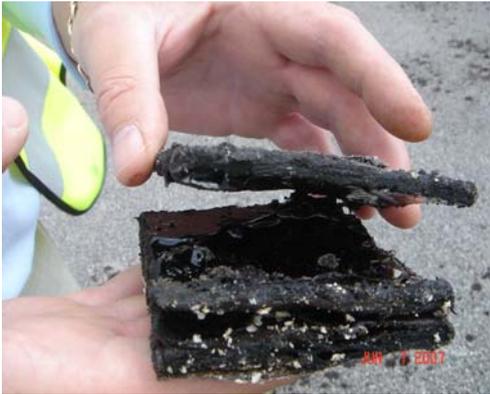
Further Confirmation of Existing Roof Build Up
